Human Led Technology

Brush Claims presents our proprietary scoping app

Interactive Training 2.0

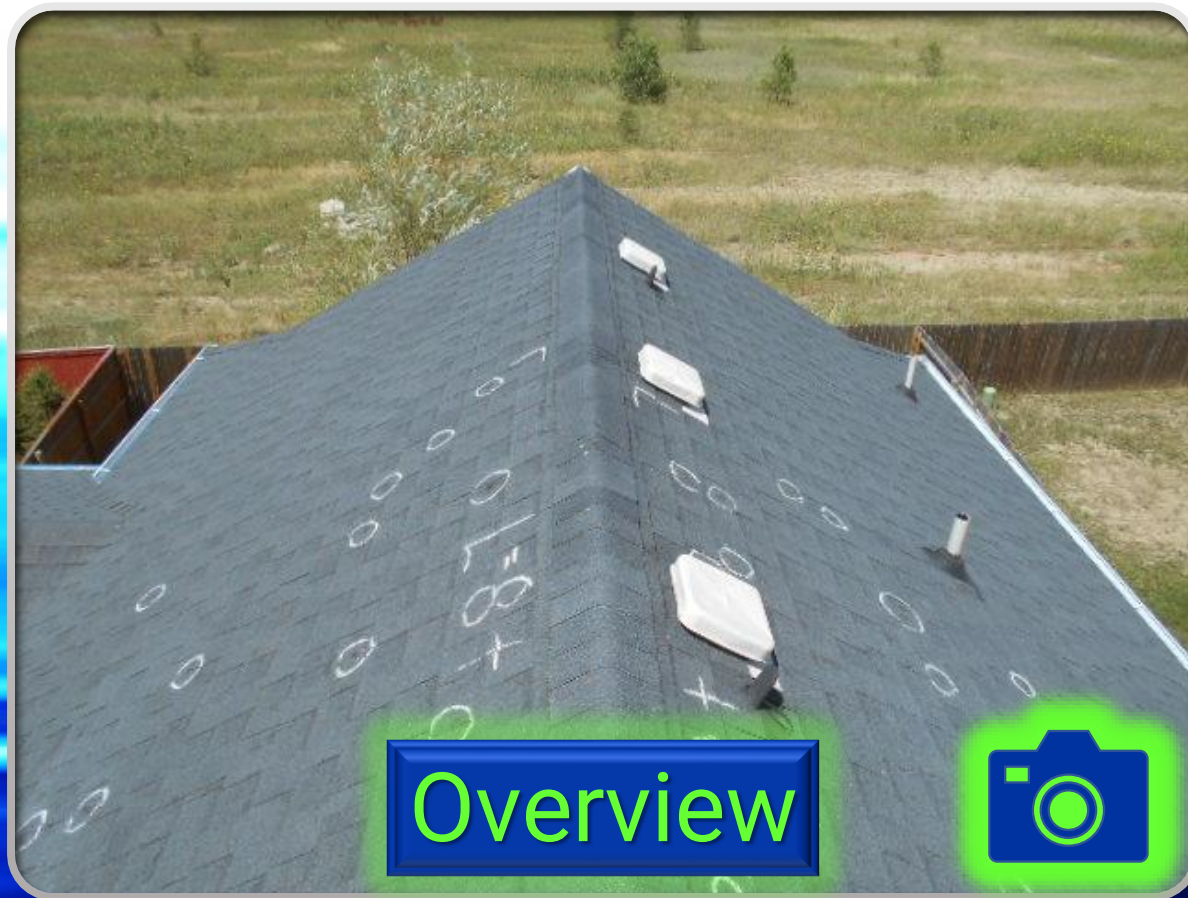
Front Slope: Overview

Pro-Tip: Complete 10X10 test square when completing hail inspections.

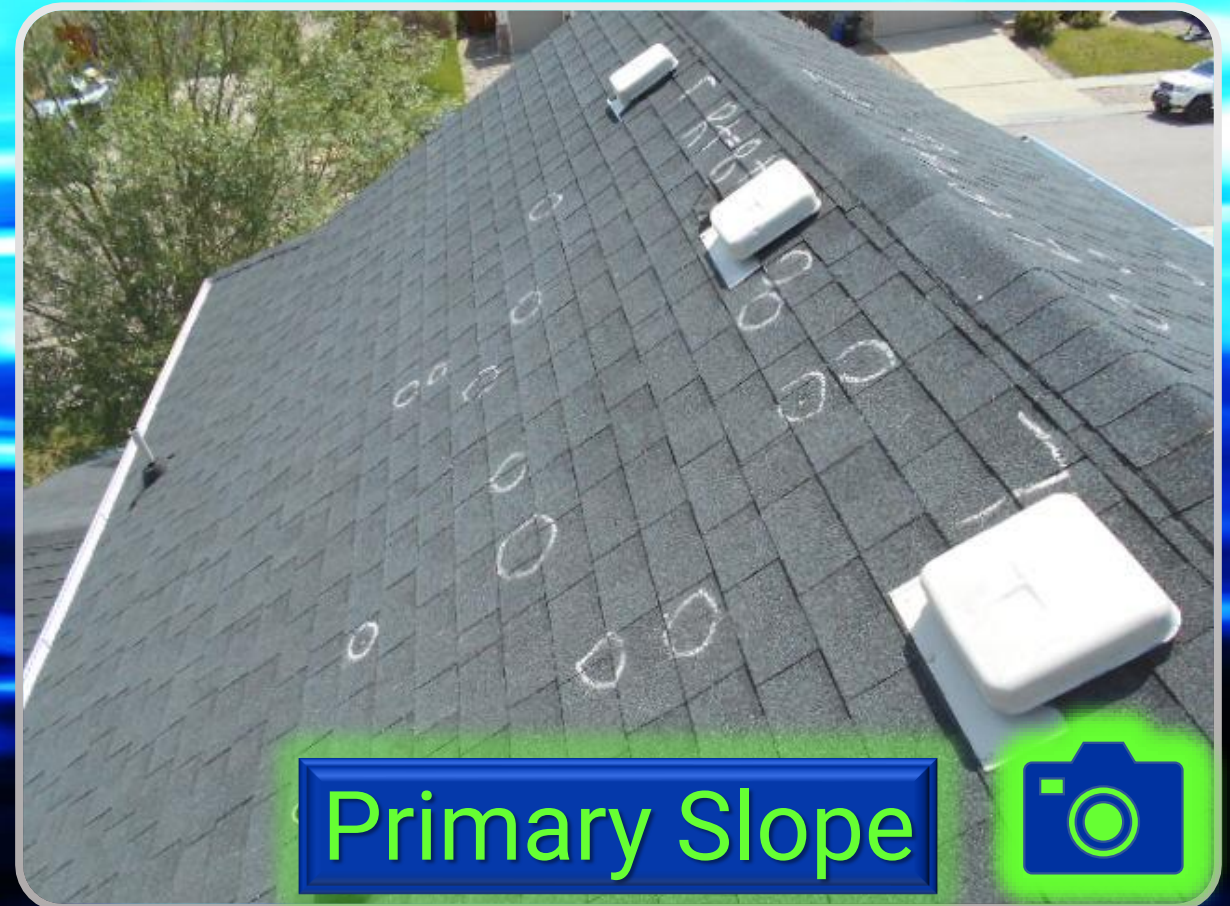
Pro-Tip: Mark damage with chalk and indicate damage on each slope prior to taking photos.

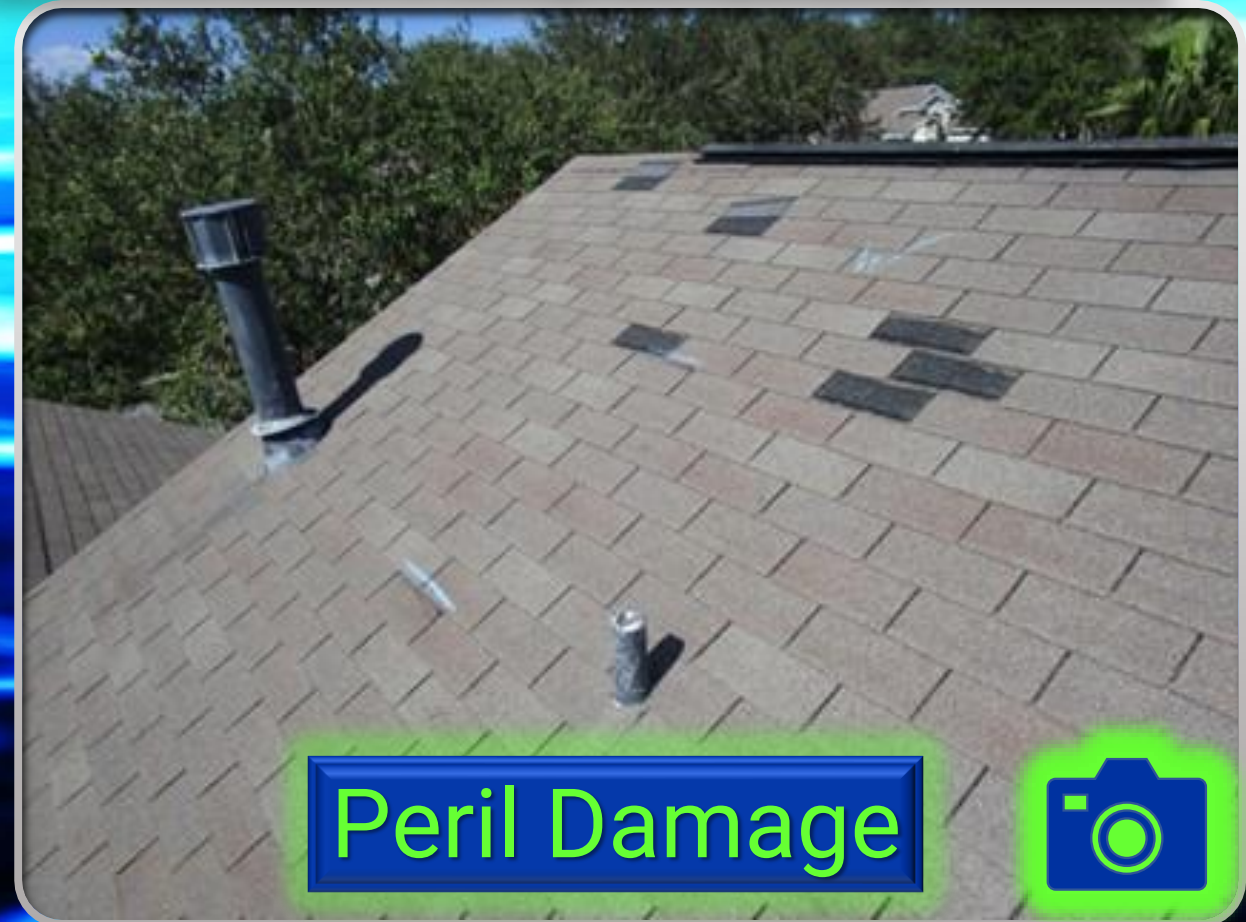
Peril Damage

Pro-Tip: Notice the “embedded” granules in the photo above of hail-damaged shingle.

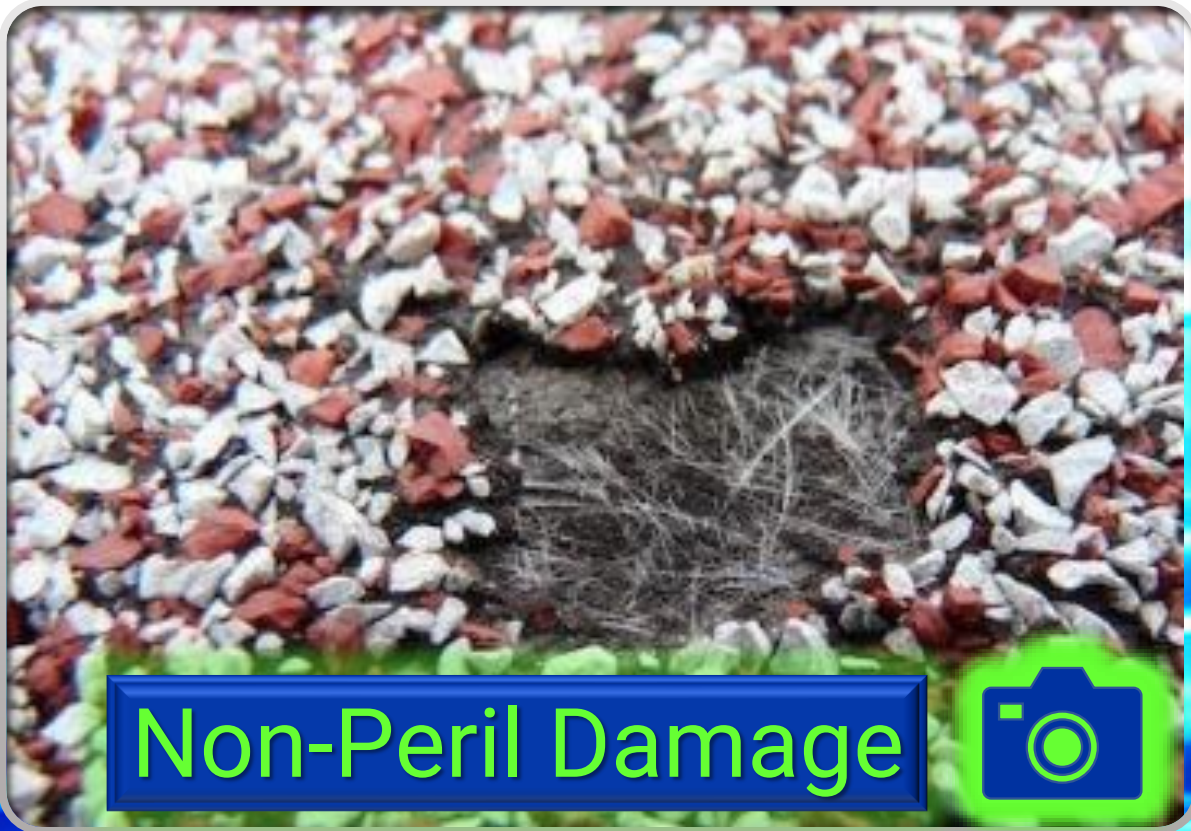
Non-Peril Damage

Pro-Tip: The above photo is a blister, commonly mistaken as hail damage. There are no "embedded" granules. Occurs due to lack of proper roof ventilation and/or manufacturer shingle defect.

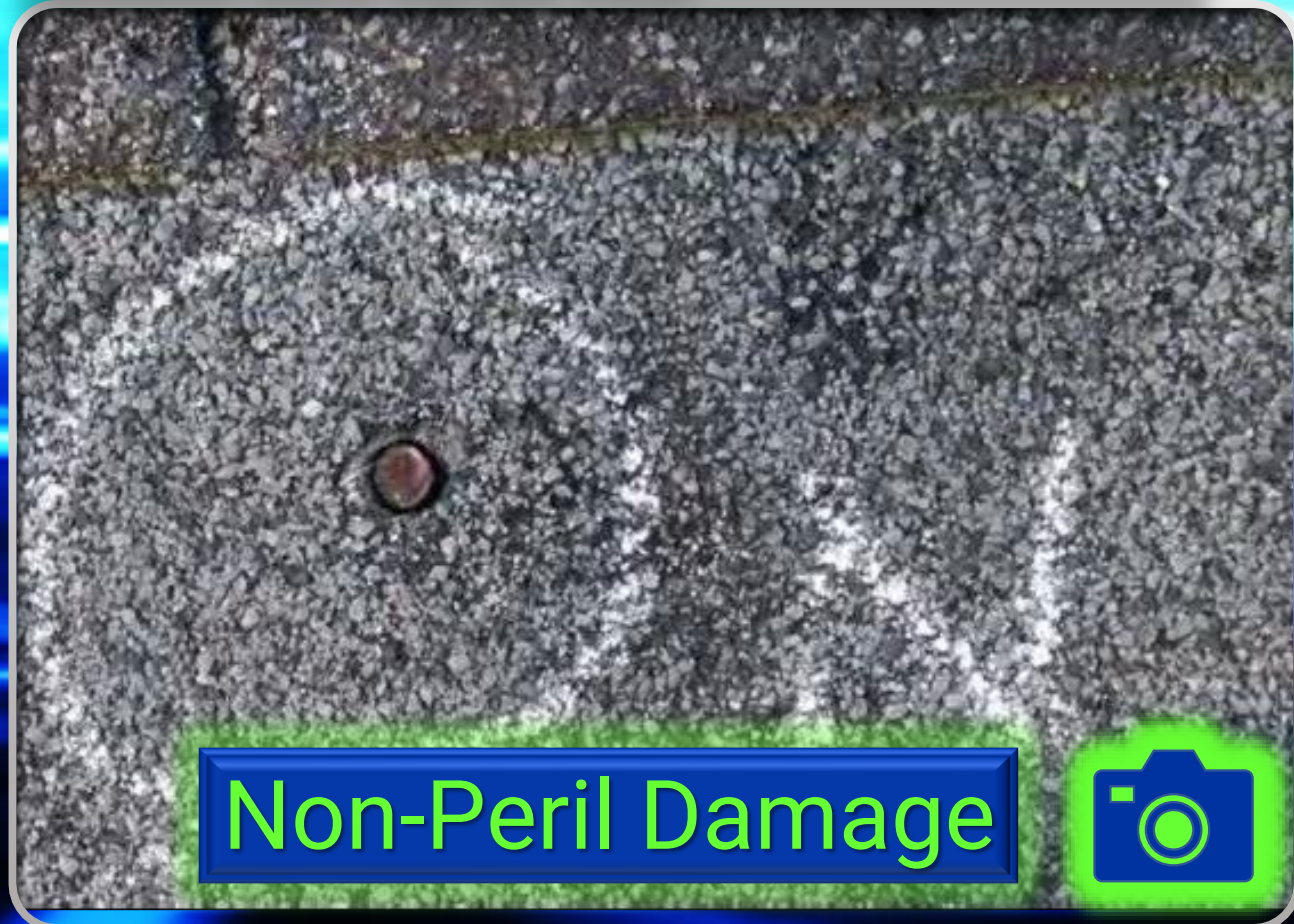
Non-Peril Damage

Pro-Tip: The below photo is a nail pop that is not sudden or accidental damage. Occurs due to lack of proper roof ventilation and/or improper install.

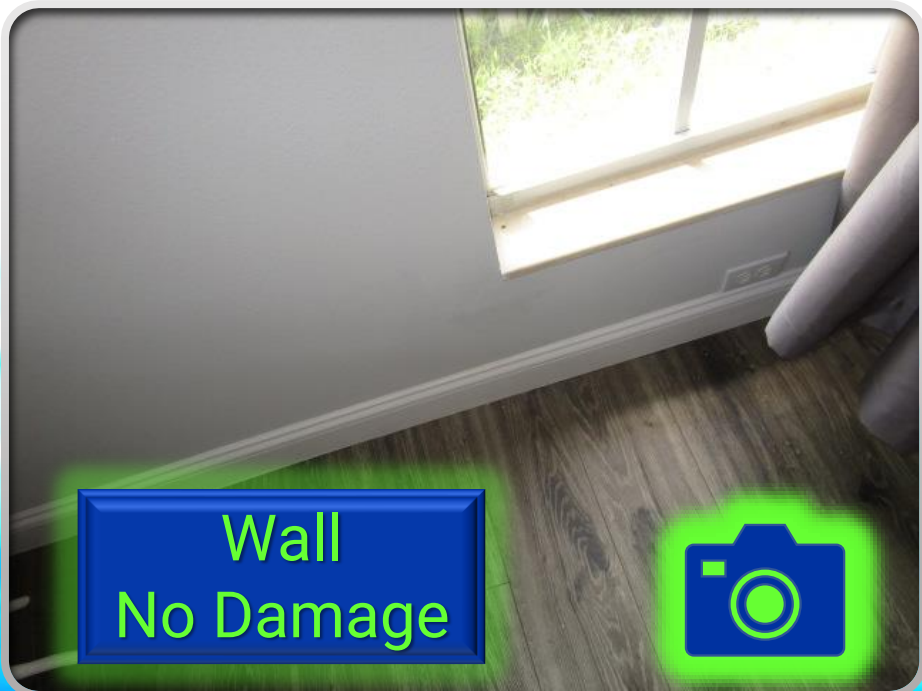
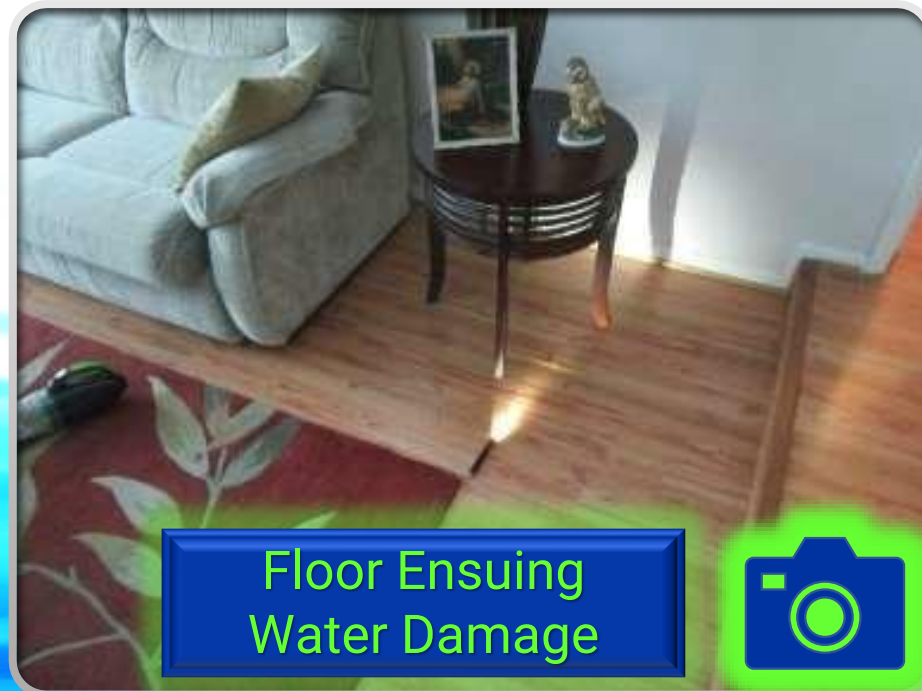
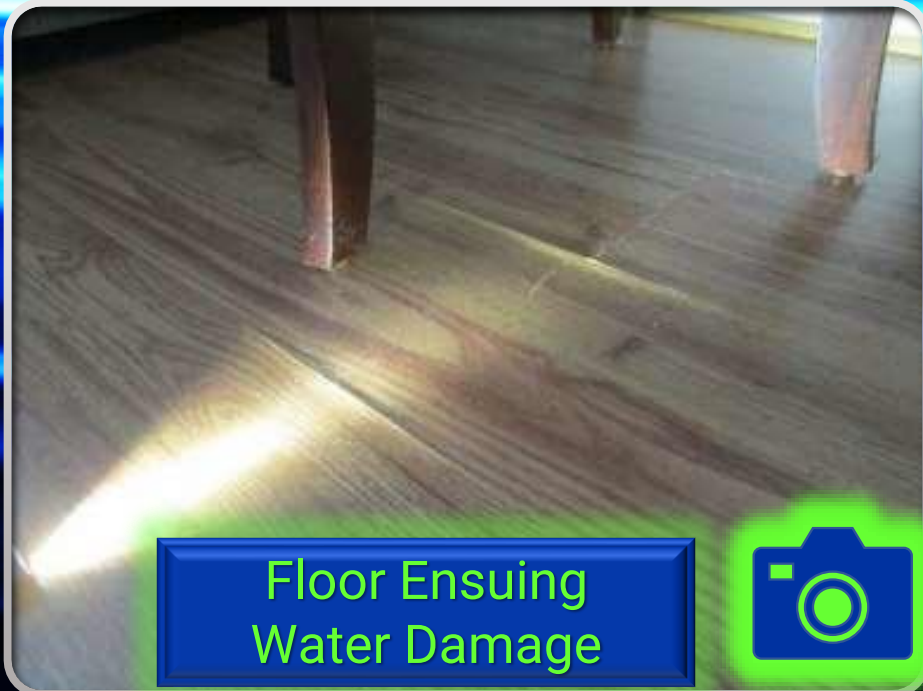
Pro-Tip: Inspect with a flashlight to cast shadows on damaged materials and they become more evident.
